N2 Langhoogte

Slope Stabilisation at Langhoogte on the National Route 2 Section 2 at KM 51.95, Western Cape, South Africa

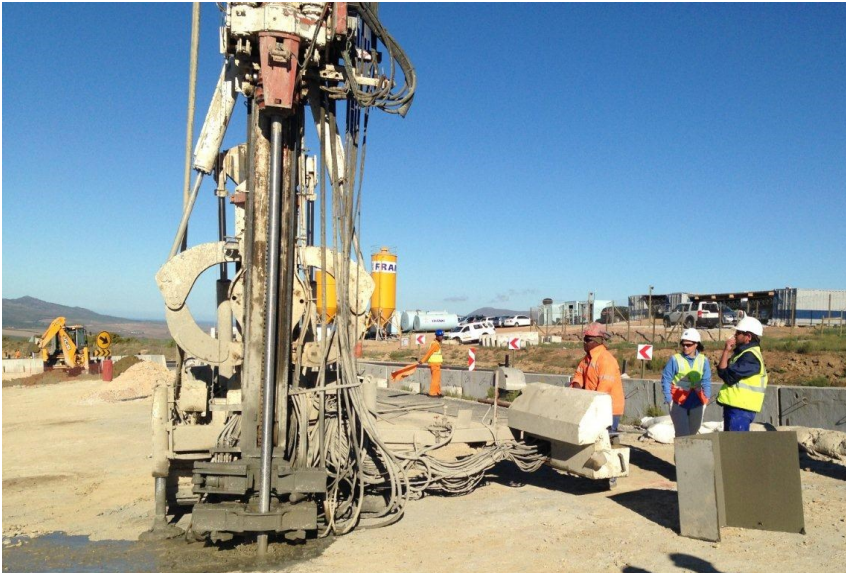
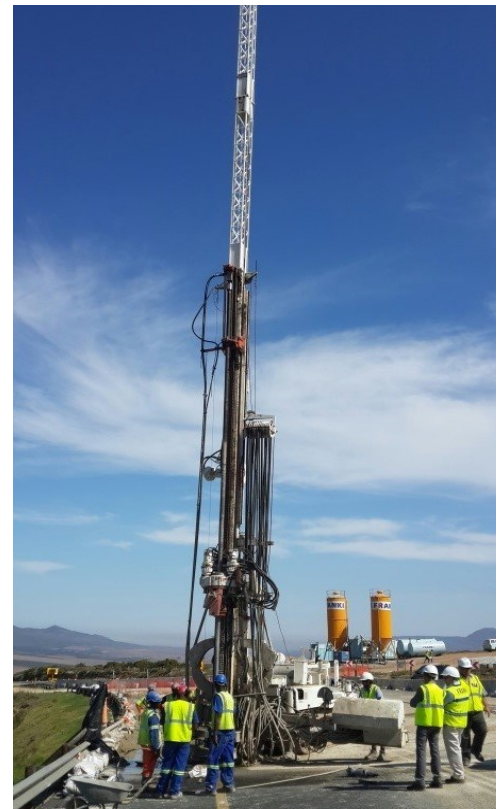
Circular crack failure has been observed at the road surface as a result of a movement of the road embankment fill. The geotechnical investigation showed that the slope failure had occurred as a result of water ingress and percolating piping of water through the underlying fill. This fact led to a design incorporating jet grouting columns, not only to stabilise the slope and roadway, but also to act as a grouting operation to fill the cavities where piping had taken place.

186 Jet Grout Columns were set out in a grid of 2.5m x 2.5m. The column depth varied between 3m and 14m depending on the insitu mudstone horizon. The column diameter of 800mm with a mushroom head of 1 200mm on the upper meter was verified through the installation of various test columns in different soil conditions.

Franki Africa entered into a contract with the South African National Roads Agency for the ground improvement (installation of jet grouting columns), roadworks (pavement rehabilitation) and drainage improvement (installation of concrete culverts).
