## MELROSE APARTMENTS

Johannesburg, South Africa

Auger Piles, Lateral Support

- 1 205m<sup>2</sup> Lateral Support
- 108 No. Auger Piles

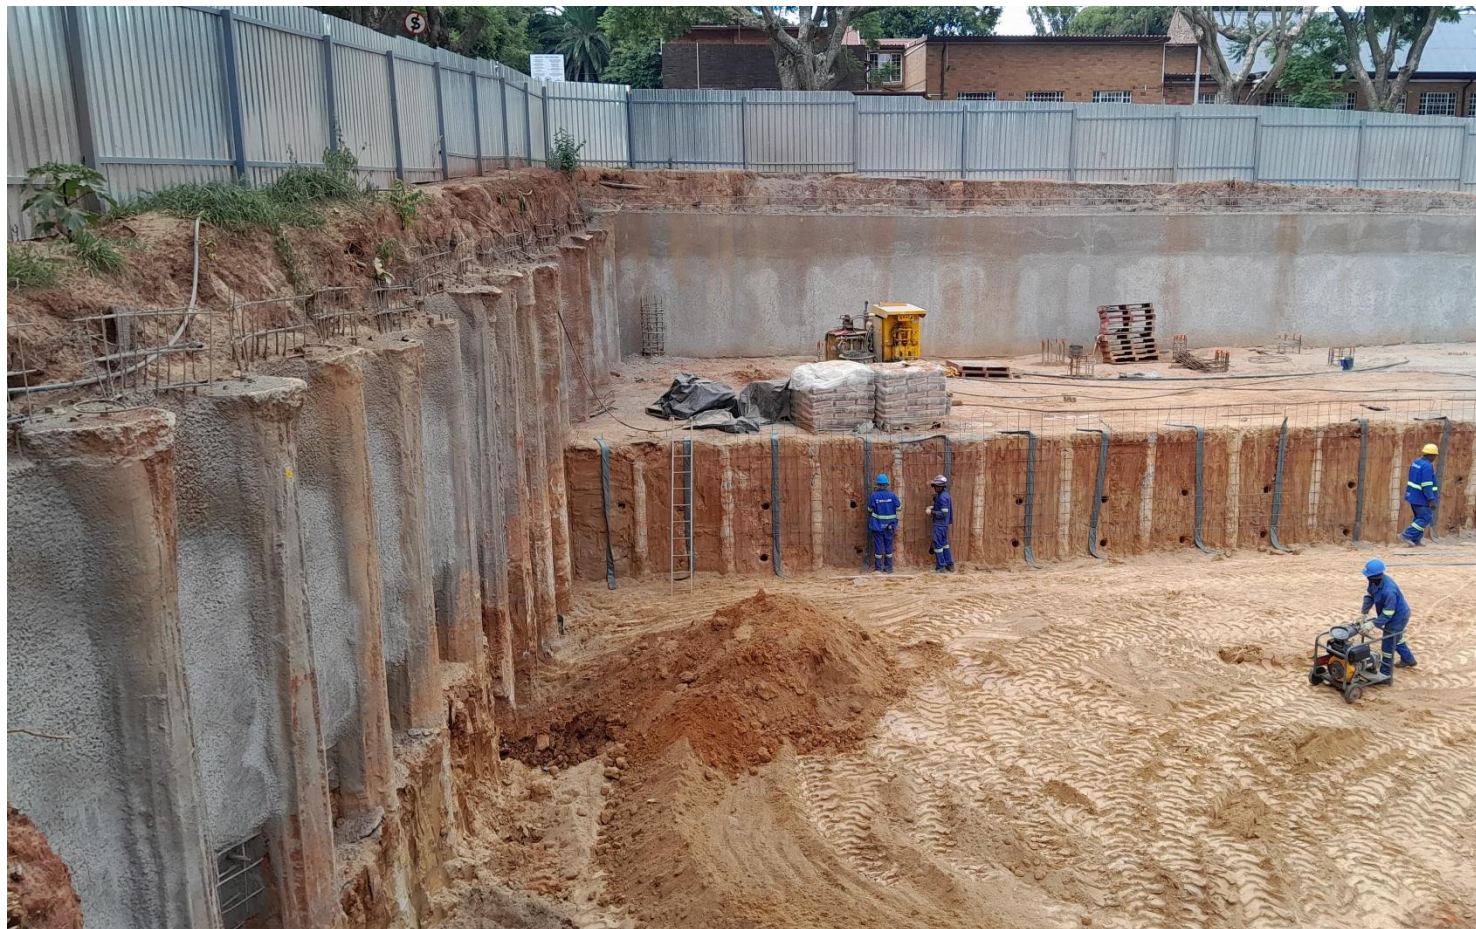
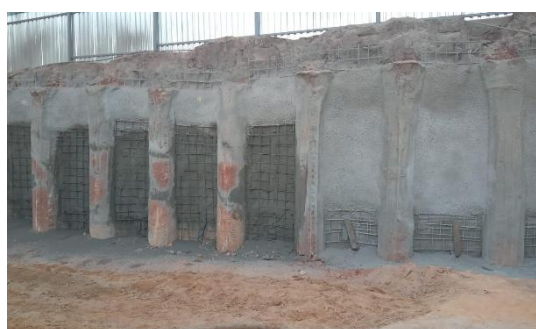
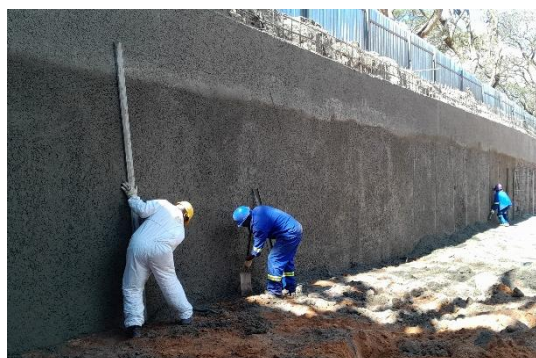
A lateral support system was implemented using embedded cantilever soldier pile walls comprising open-hole auger and DTH piles, in combination with arched and flat shotcrete infill panels.

Designing a 7m high cantilever soldier pile wall in an urban environment surrounded by buildings and services posed significant challenges.
