## THE DAILY

Cape Town, South Africa

Lateral Support

2 040m<sup>2</sup> Lateral Support  
21 550 m<sup>3</sup> Bulk Earthworks

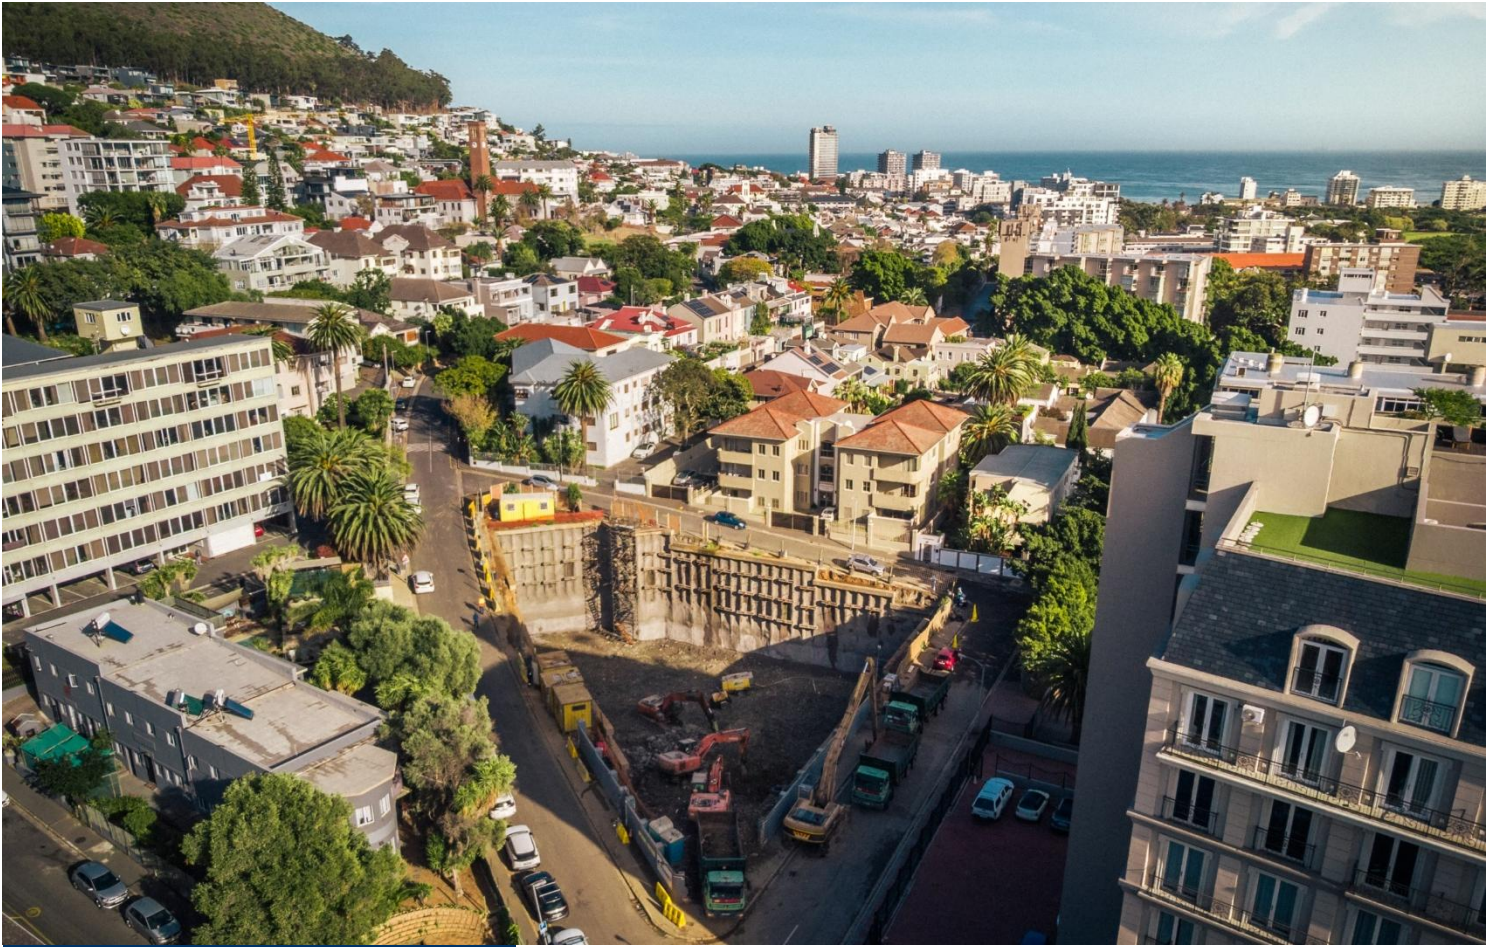
CFA soldier piles were installed with one to three rows of temporary grouted anchors, tailored to excavation depth. Additional support was added below the pile toes where necessary.

Heavy machinery and hydraulic breakers were used to excavate bedrock. Overbreak areas were stabilised with shotcrete to maintain clean-cut faces.
