## The project

Student accommodation in Lower Observatory, Cape Town. OBS Court comprises of eight residential levels, one parking level above ground and three below ground. The building's facilities include a gym, rooftop pool and braai area, as well as a Seattle Coffee Co. on the first floor.

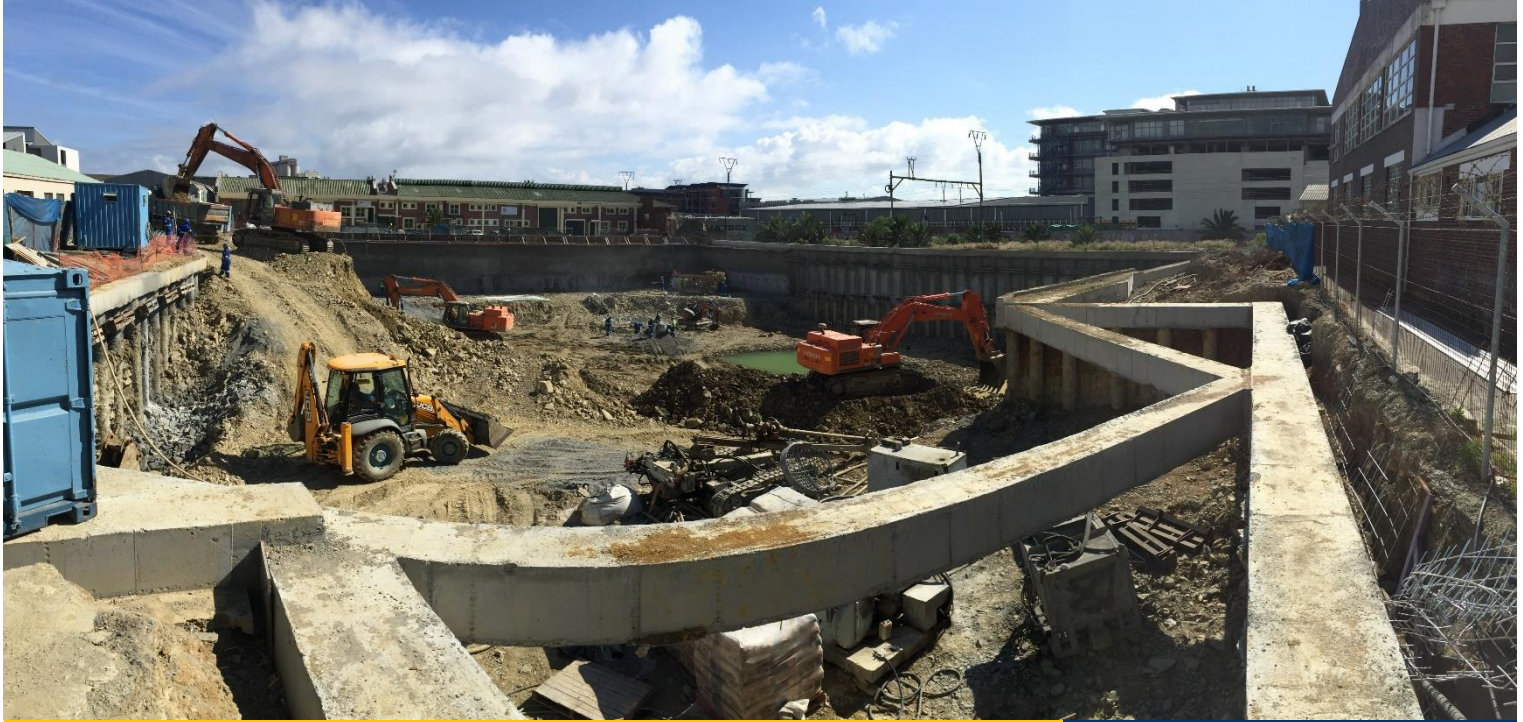
Lateral support incorporated soldier piles with gunite arches and anchor as well as certain areas that required only a 200mm anchored gunite wall..

In other areas where no anchors were permitted, bracing for the lateral support was achieved through concrete cast in-situ bracing beams.

- Dealing with old railway servitude and demolition on the site.
- On one boundary permission could not be obtained for temporary anchors below the neighbouring premises and temporary props had to be cast into the capping beam in this area.
- Large stormwater pipes along the length of the site, required anchors above and below it.
